INSPECTION, MAINTENANCE AND REPLACEMENT OF STAY CABLES

Reiner Saul* and Karl Humpf†

*† Leonhardt, Andrä und Partner, Beratende Ingenieure VBI, GmbH
Lenzhalde 16, 70192 Stuttgart, Germany
e-mail: saul@s.lap-consult.com, humpf@s.lap-consult.com, web page: www.unibw-mbac.net

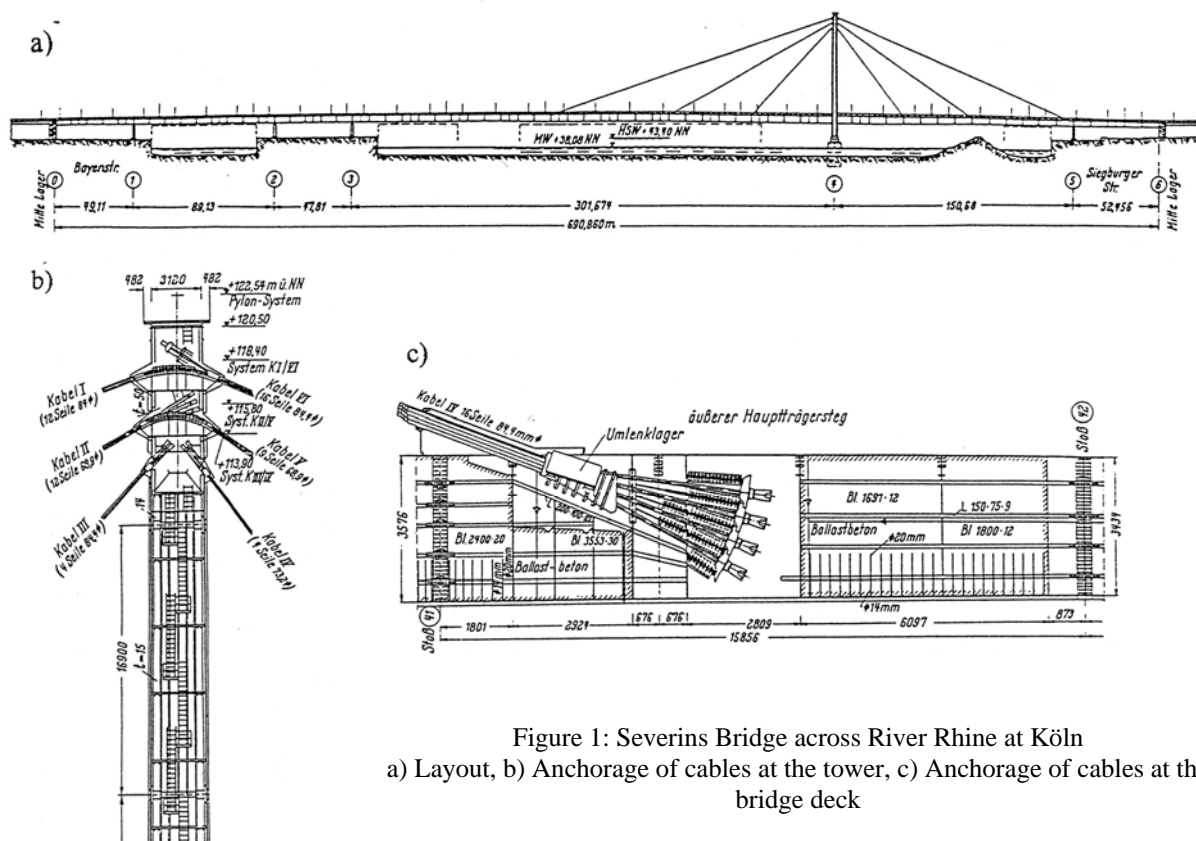
Figure 1: Severins Bridge across River Rhine at Köln
 a) Layout, b) Anchorage of cables at the tower, c) Anchorage of cables at the bridge deck

As at the time of building the first cable-stayed bridges powerful computers had not been developed yet, engineers tried to limit the number of static indeterminacies by having very few concentrated stay cables only which passed in the tower over movable or rotatable saddles, Fig. 1; at the bridge deck they were kept together by spread saddles and individually anchored by sockets.

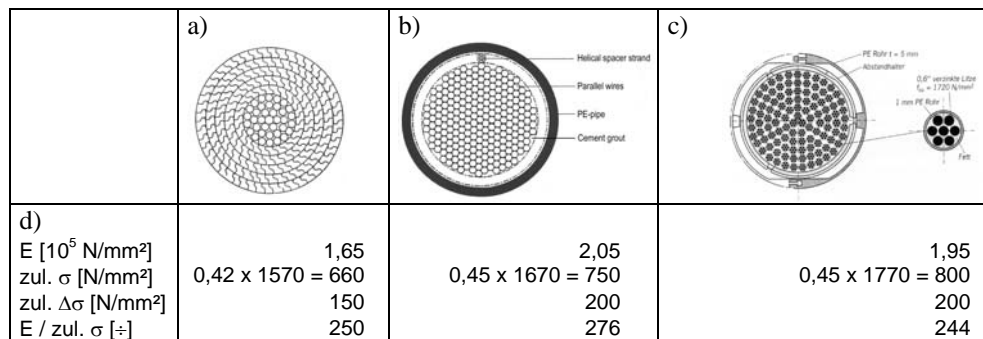
Figure 2: Cross sections of stay cables

a) Modern locked coil rope, b) Parallel wire cable, c) Parallel strand cable, d) Main characteristics

As manifold as the static system and the cable arrangement are the structural detailing and design of the cables. Nevertheless, only two cable types have world-wide achieved broad application: the locked coil ropes and the parallel wire or parallel strand cable, using prestressing wires and strands, Fig. 2, where the main characteristic of both cable types are also given.

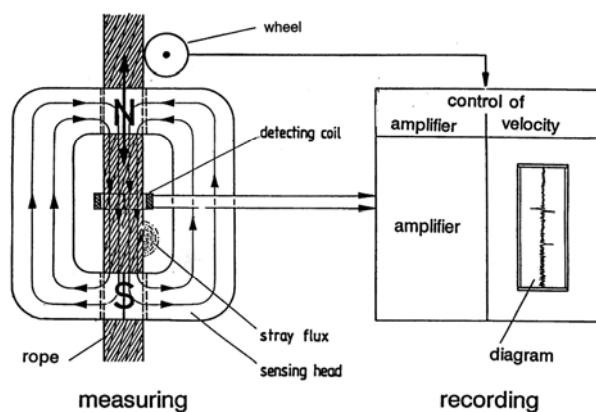
Figure 3: Scheme of Electromagnetic inspection

Electromagnetic (EM) inspections allow examinations of the interior of the cable. These inspections show external as well as internal cracked or broken wires, abrasion and most important: corrosion in the inside of a cable or on the outside under an apparently undamaged corrosion protection coating. Practical instruments for in-service wire rope inspections were first developed in 1930 for e.g. the ropes used in the coal mines or in cable cars. Instruments which can simultaneously detect localized faults and measure loss of metallic cross-sectional area were used for the inspection of bridge cables in Germany since about 1970, Fig. 3, and nowadays instruments for all cable types are available.

The instruments are pulled along the cable with a winch and the test signals can be recorded or stored and processed.

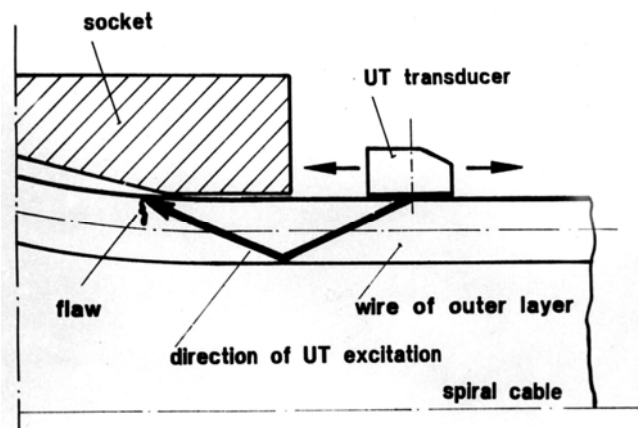
Figure 4: Scheme of ultrasonic inspection

In order to detect eventual wire cracks inside of cable anchorages, special ultrasonic inspection methods have been developed which allow to control the entrance of the cable into these elements, Fig. 4, and over the entire embedded length.

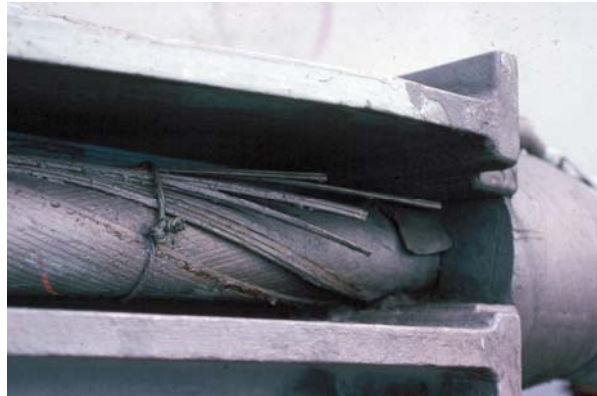
Figure 5: Köhlbrand Bridge at Hamburg: Lower cable anchorage with broken wires

During a 1976 inspection of the cables, 25 broken wires were detected, Fig. 5. An in-depth analysis of the possible causes of these damages showed that the following factors had contributed:

- a) Structural detailing: The cable anchorages are positioned not in the tangent, but in the secant. This causes secondary stresses due to the bending stiffness of the ropes. The sockets and the entrance of the cables into the sockets were not protected against the access of humidity and splash-water, so that aggressive agents were concentrated in small cracks and gaps of the socket casting at this critical point. The ropes were protected by lead collars against direct contact with the anchor beams. Due to its electric potential difference lead facilitates the corrosion of steel.

- b) Sizing: Although there is a very heavy truck traffic on this light-weight steel bridge, a sizing against fatigue was not made as DIN 1073 did not require it at that time. Frequent cable oscillations with great amplitudes were observed, which could not be explained by vortex shedding but as anchorage excitation due to $f_{\text{girder}} = 2f_{\text{cable}}$. In some cables the forces due to permanent loads were so small that in combination with unfavourable live load – and assuming constant cable stiffness – compression was obtained. The cables then cease to be locked and humidity may penetrate into them.

- c) Design and application of the corrosion protection: As mentioned earlier, the wires were not galvanized. During the hot metal casting of the sockets with temperatures of about 425°C, the inner corrosion protection in front of the sockets was burned. Due to the shims, bearing bars etc. in front of the sockets, the outside painting in this area is poor.

All these factors have contributed to the wire breaks, but an exact quantification cannot be given due to the rather complex interaction among them. Nevertheless, the fact that 22 out of the 25 broken wires were found at the lower cable anchorages indicates the outstanding contribution of the de-icing salt.

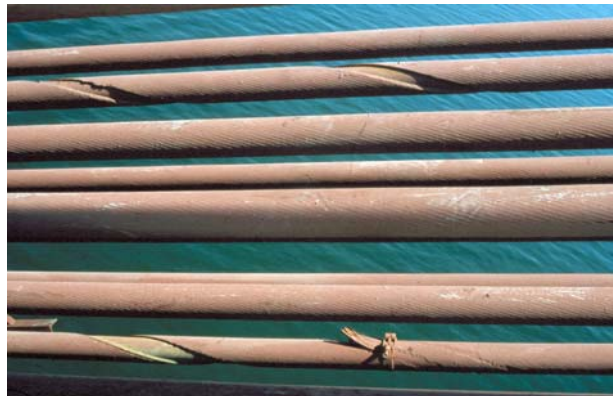
Figure 6: Maracaibo Bridge, Broken Wires

Between 1974 and 1978, several broken wires were detected. An in-depth inspection at the end of 1978 showed more than 500 broken wires, Fig. 6, and in early 1979 3 ropes had broken completely.

The damages were caused mainly by two phenomena: The general lack of maintenance of the painting in the hot maritime climate; and the neoprene boots had not been reinstalled after an inspection, so that a permanently humid microclimate was established underneath the wooden plugs.

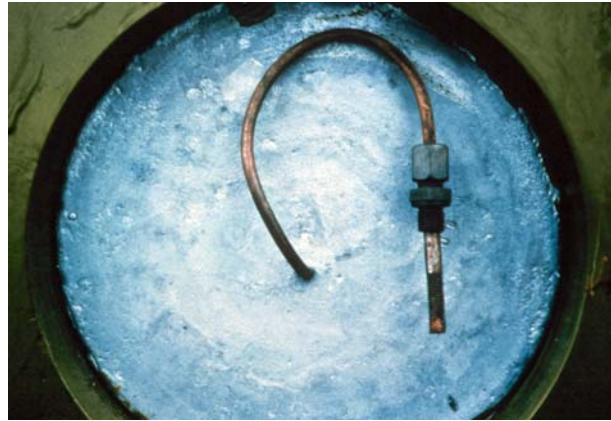
Figure 7: Socket with injection pipe

c) As the inner protection of the ropes is burned by the hot metal casting, it has to be replaced by injection, Fig. 7.

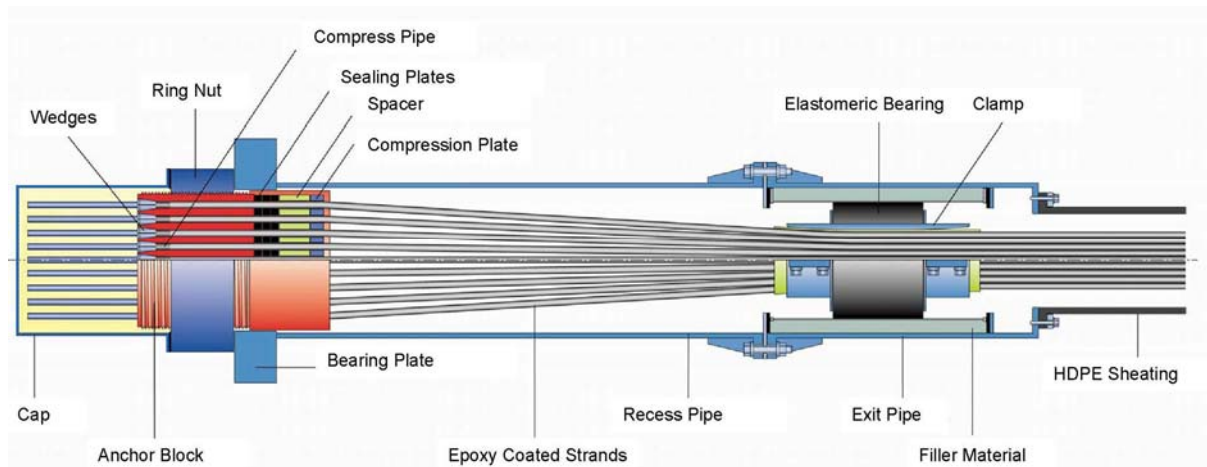
Figure 8: Parallel strand cables with “wedge only” anchorage

The individual strand may be anchored in the sockets

- by wedges for permanent loads and by wedges and a chemical compound, e.g. epoxy resin, for live loads
- by high fatigue wedges only for all loads.

The latter anchorage allows the replacement of individual strands and may be considered the state of the art of stay cables using prestressing steels, Fig. 8
